Confidential Technical Report NE4616

TIMESCO CALLISTO LARYNGOSCOPE TESTING.

Timesco of London Ltd.

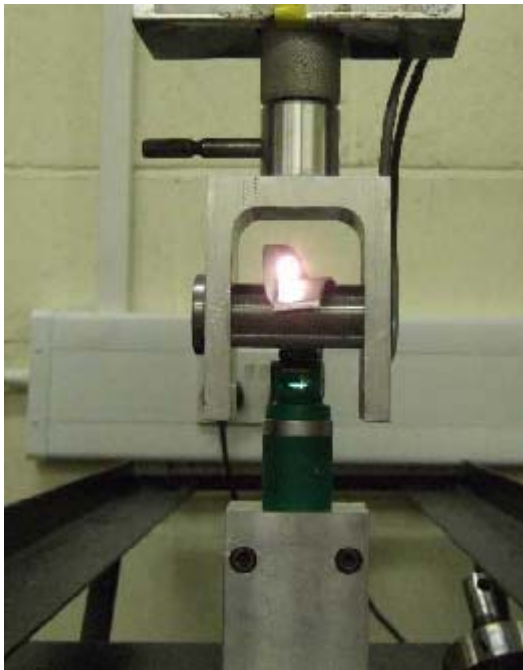
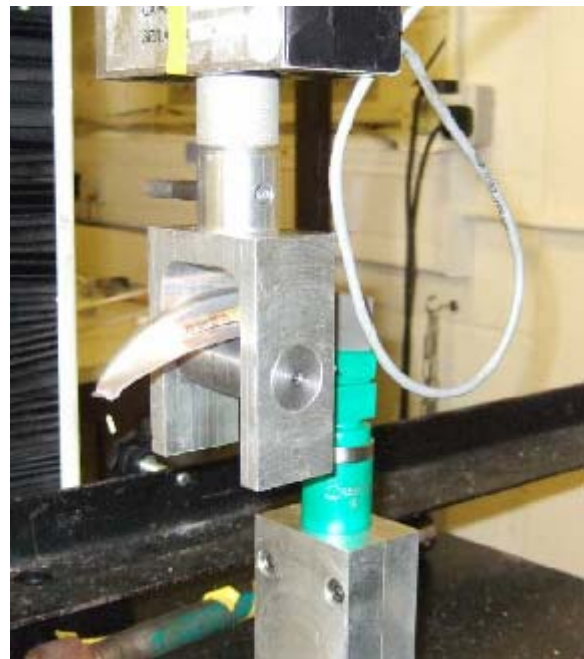
Photographs of test fixture with laryngoscope fitted

A fixture was produced which would grip the handle of the device and could be attached to a tensile test machine. A second fixture was also designed to apply an upward vertical load to the centre of the blade simulating the service orientation (see photographs in the appendix to this report). A load of 30 N was applied and maintained for 5 minutes. During this time the interface between the threaded collar was inspected for any distortion or detachment. At the end of 5 minutes, the load was increased at a speed of 5 mm/min until failure occurred.

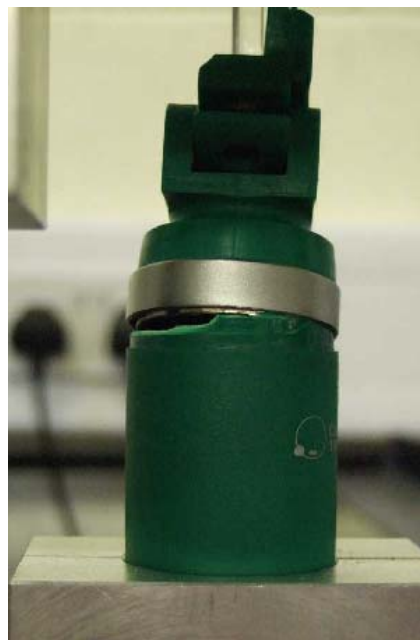
Sample No.	Proof Load, 30 N	Load at Failure (N)	Comments
1	OK, no damage	327	Blade detached, no damage to collar
2	OK, no damage	305	Top of battery holder failed, collar detached
3	OK, no damage	307	Top of battery holder failed, collar detached
4	OK, no damage	323	Blade detached, small gap opened under collar
5	OK, no damage	315	Blade detached, no damage to collar
6	OK, no damage	316	Blade detached, no damage to collar
7	OK, no damage	323	Blade detached, small gap under front of collar
8	OK, no damage	315	Cap detached from thread. Threads damaged then blade detached
9	OK, no damage	326	Blade detached. Very small gap opened under front of collar
10	OK, no damage	303	Blade detached, plastic mounting failed. No damage to collar.

Photograph of sample 2 after test

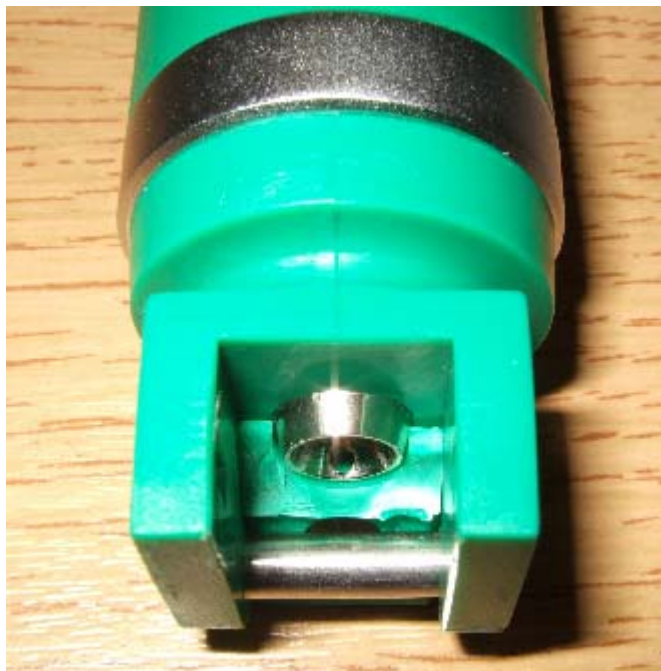
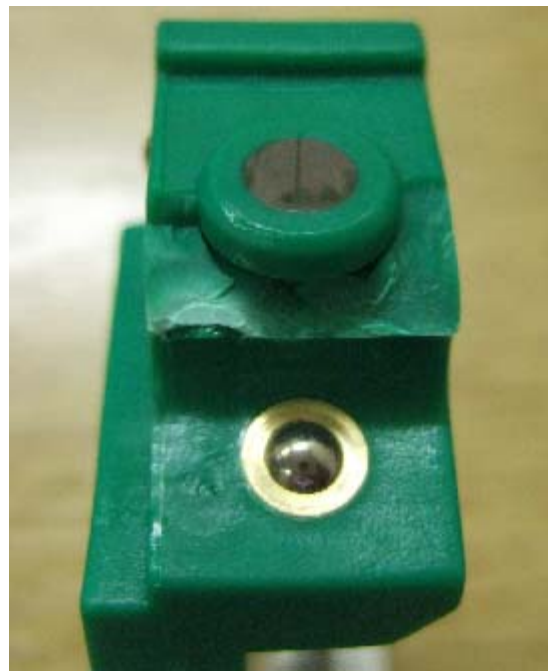
Photographs showing failure site on blade retention mechanism on Sample 10
