Confidential Technical Report NE4548

LARYNGOSCOPE TESTING.

Timesco of London Ltd.

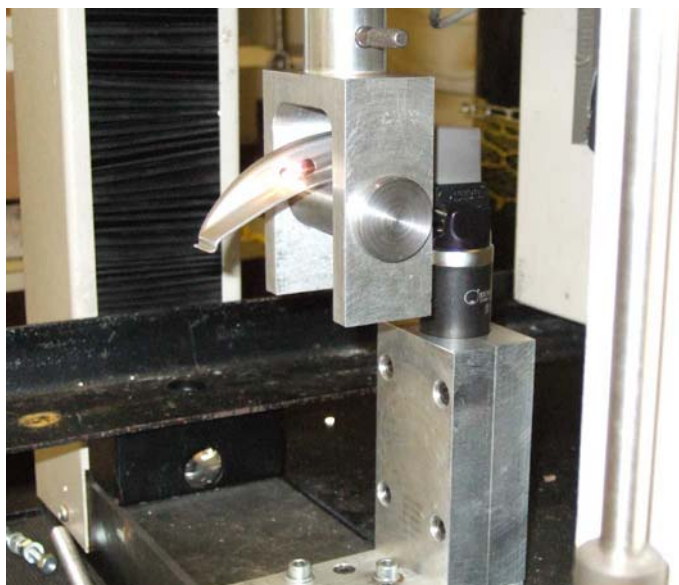
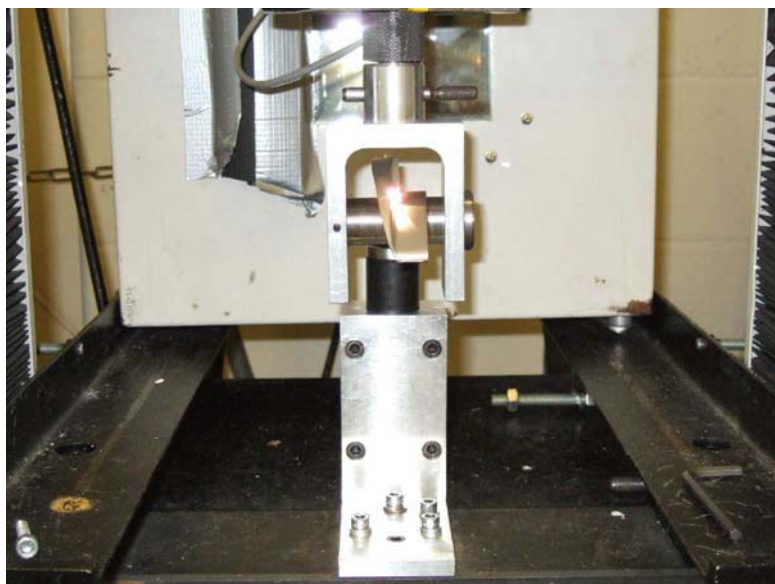
Appendix to CTR NE4548

Photographs to test fixture with laryngoscope fitted

A fixture was produced which would grip the handle of the device and could be attached to a tensile test machine. A second fixture was also designed to apply an upward vertical load to the centre of the blade simulating the service orientation (see photographs in the appendix to this report). A load of 30 N was applied and maintained for 5 minutes. During this time the interface between the threaded collar was inspected for any distortion or detachment. At the end of 5 minutes, the load was increased at a speed of 5 mm/min until failure occurred.
